11. TITLE (Include Security Classification) Rehabilitation of Navigation Lock Walls: Case Histories					
12. PERSONAL AUTHOR(S) McDonald, James E.					
13a. TYPE OF REPORT Final Report	13b. TIME COVERED FROM TO	14. DATE OF REPORT (Year, Month, Day) December 1987		15. PAGE COUNT 316

means for removing large quantities of concrete. Once the deteriorated concrete has been removed, conventional cast-in-place concrete has been used as the replacement material in most lock wall rehabilitation projects. Other replacement systems that have been used or proposed include shotcrete, preplaced-aggregate concrete, and precast concrete stay-in-place forms. In addition, several materials including latex-modified concrete, polymer mortars and grouts, conventional shotcrete, and latex-modified, fiber-reinforced shotcrete have been used as thin overlays on existing lock walls. Applications of the various rehabilitation systems and their performance to date are described in selected case histories.

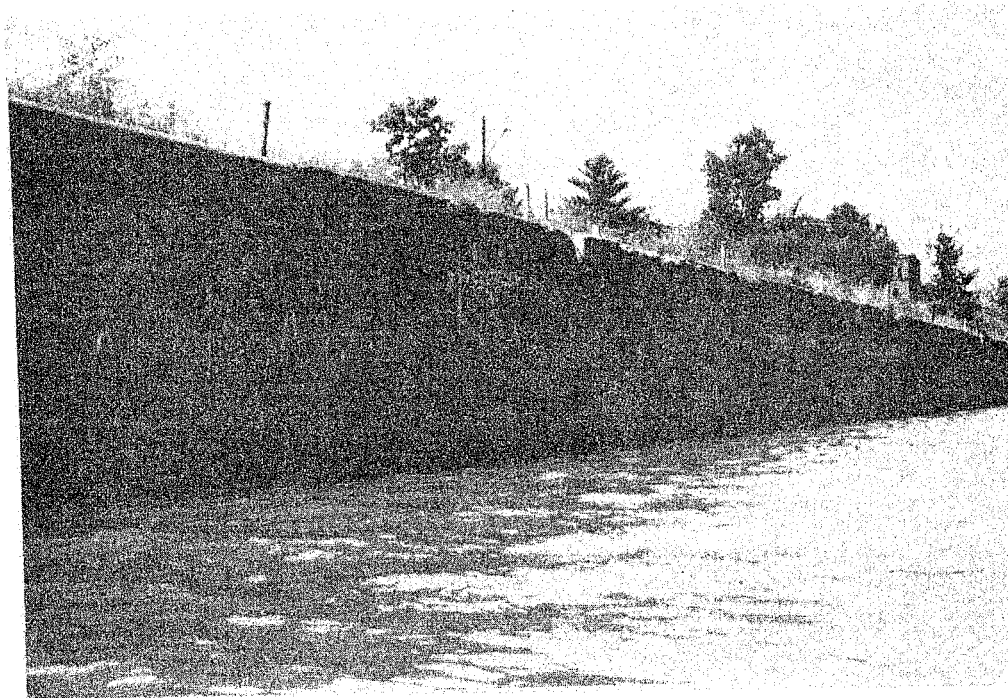
Figure 3. Condition of land wall, July 1985,  
Lock No. 5, Monongahela River

23. Lock No. 5 was removed from service and, with the exception of the land wall, razed in conjunction with the construction of Maxwell Lock and Dam in 1964. A visual examination of the remaining wall in July 1985 showed that the preplaced-aggregate concrete had some cracking and leaching (Figure 3) but overall appeared to be in generally good condition after 35 years exposure.

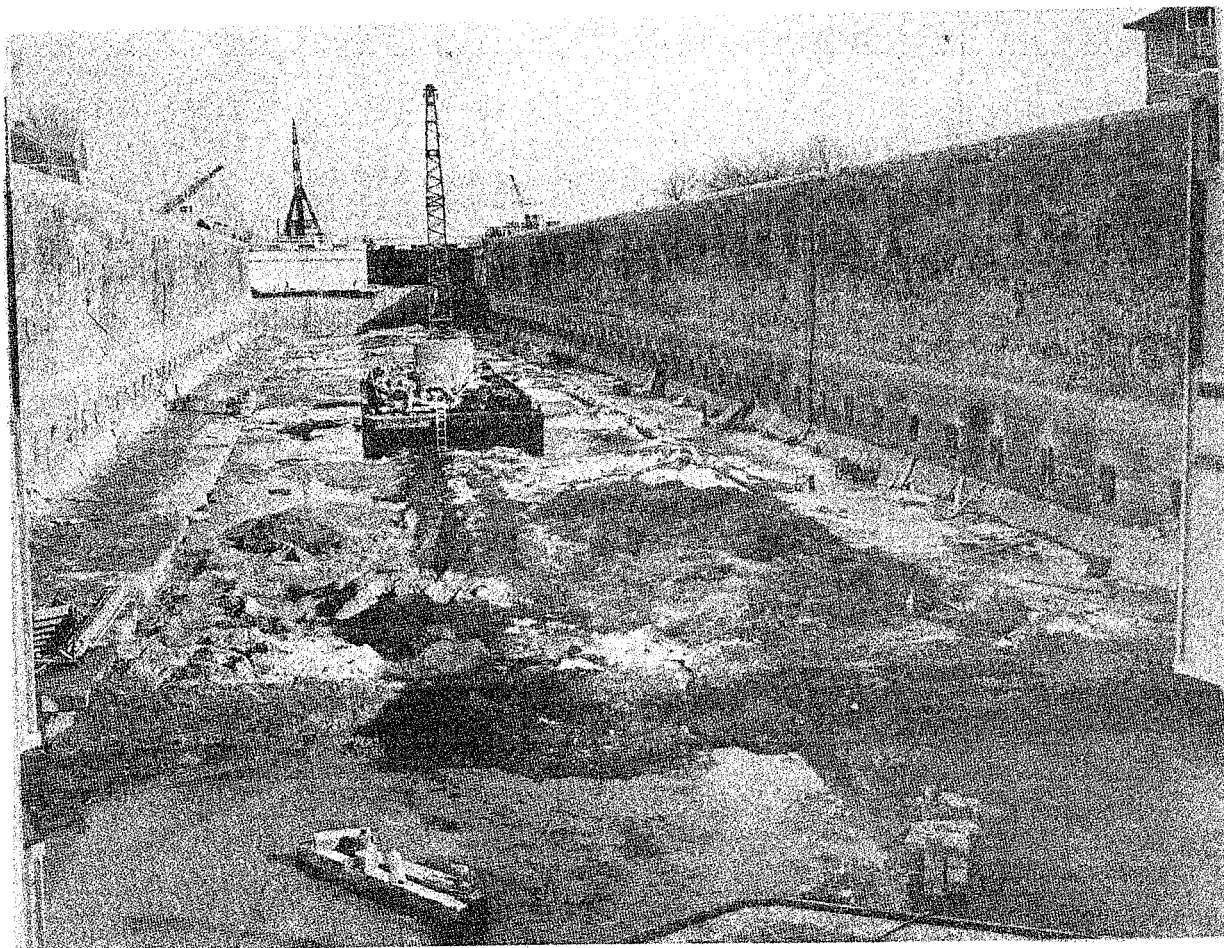
Figure 5. Lock chamber dewatered for repairs, 1952, Marseilles Lock

25. The lock was dewatered for major repairs during January and February 1952. The repair work included the following major items: (a) repair upper and lower gates, (b) reconstruct upper and lower miter sills, (c) repair recess in guide walls for cofferdam, (d) sandblast and paint upper and lower gates, (e) valve and valve well repairs, (f) reconstruct stop log recesses (valve), and (g) install flange reinforcement ties in upper and lower gates. Total cost of the repairs was \$331,500. Although there appeared to be some slight scaling of the lock chamber walls between upper and lower pool elevations (Figure 5), overall the concrete appeared to be in good condition.

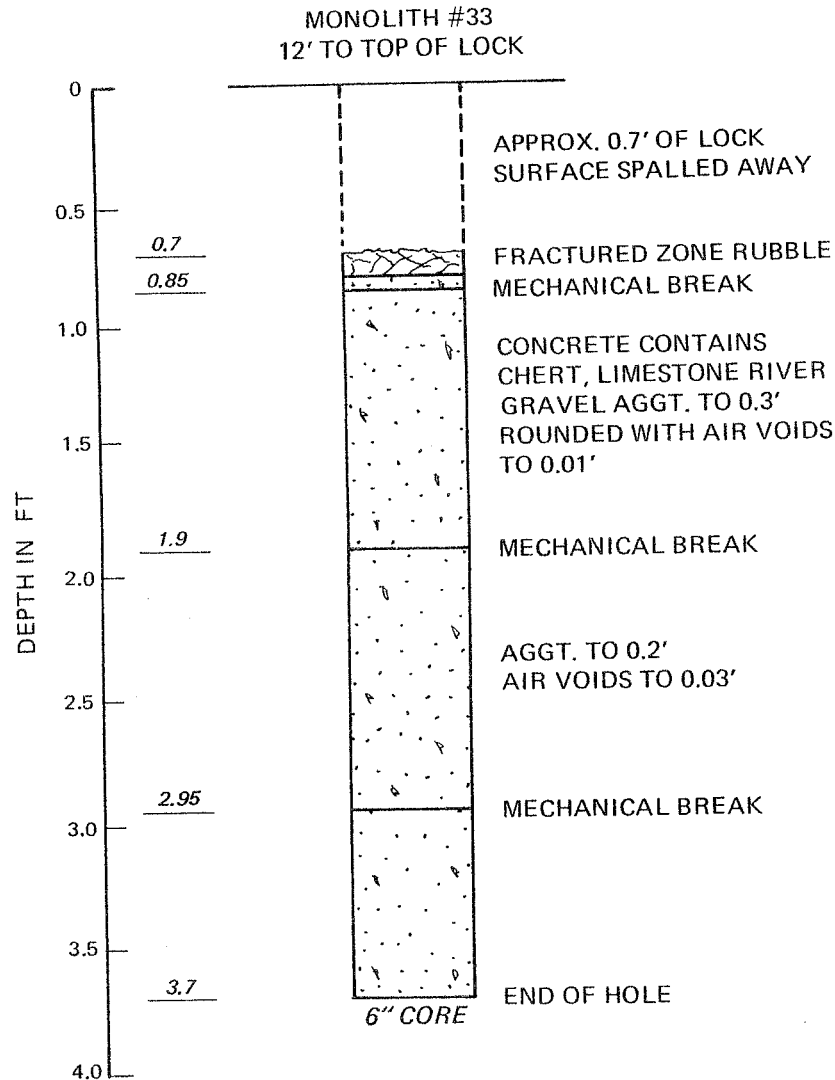
Figure 11. Typical concrete core log, 1974,  
Marseilles Lock

- i. The depth of deterioration appeared to be greater between elevations 482.7 and 471.5 (average of 1.08 ft) than between elevations 471.5 and 465.0 (average of 0.76 ft).
- i. The core from all borings was tested with the Schmidt Impact Hammer. The results were inconclusive due to the inconsistency and variability of the readings.

No conclusions were drawn from the test results regarding the causes of concrete erosion. Lack of air entrainment, weathering of siltstone particles, and severe freeze-thaw environment were believed to be some of the factors contributing to the erosion.

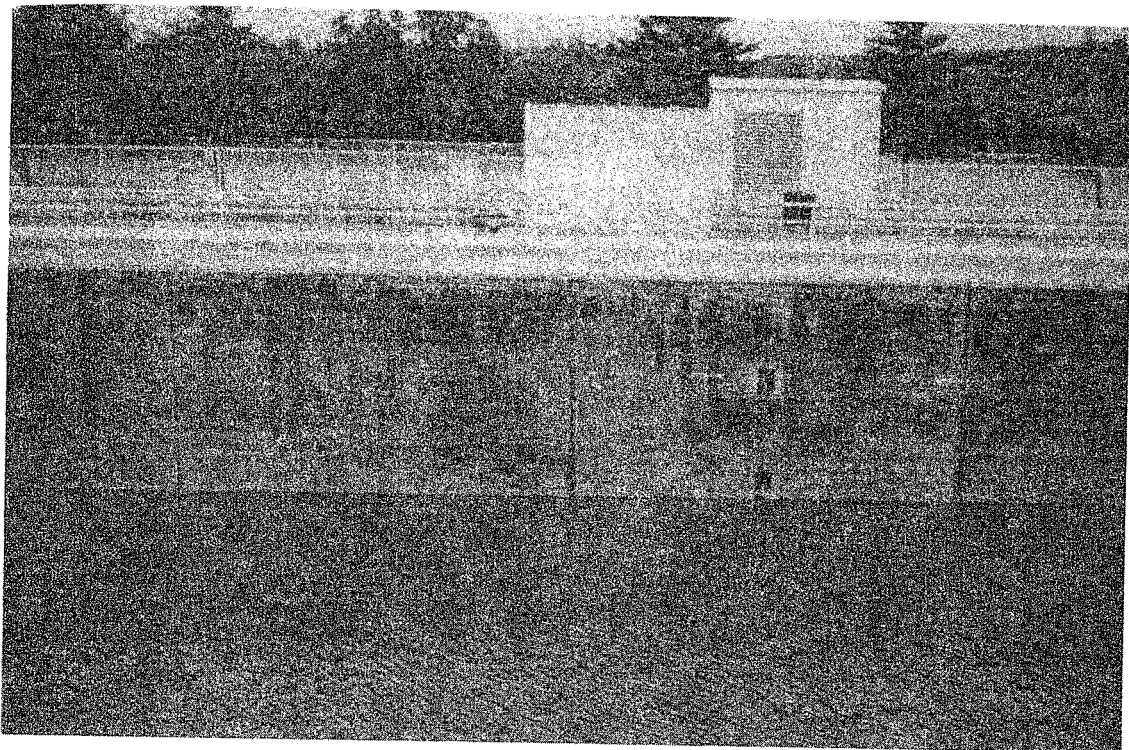
42. The epoxy applications were a "fiasco" (Juzenas 1979). Delamination of the epoxy layer below the top corner protection plate of the lock wall started within days after reopening of the lock to the waterway traffic. In many places the epoxy mortar was rubbery and easily bent by hand. The Waterways Experiment Station (WES) was engaged to determine the causes of the failure. Upon performance of a battery of tests on the materials and on samples taken from the wall, WES concluded that delaminations were predominantly caused by barge impacts on the epoxy mortar overlay that was poorly bonded to the underlying material. Lack of cleaning and smoothness of the underlying material were thought to be the principal contributing factors in producing a poor bond. The extraction tests indicated that insufficient curing caused the epoxy mortar to be soft. Insufficient curing was attributed to improper mixing or proportioning. As a result of the epoxy mortar failure, a horizontal steel plate was used to cover the failure area (Figure 14).

Figure 14. Steel plate below corner protection armor used to cover epoxy mortar failure, May 1985, Marseilles Lock

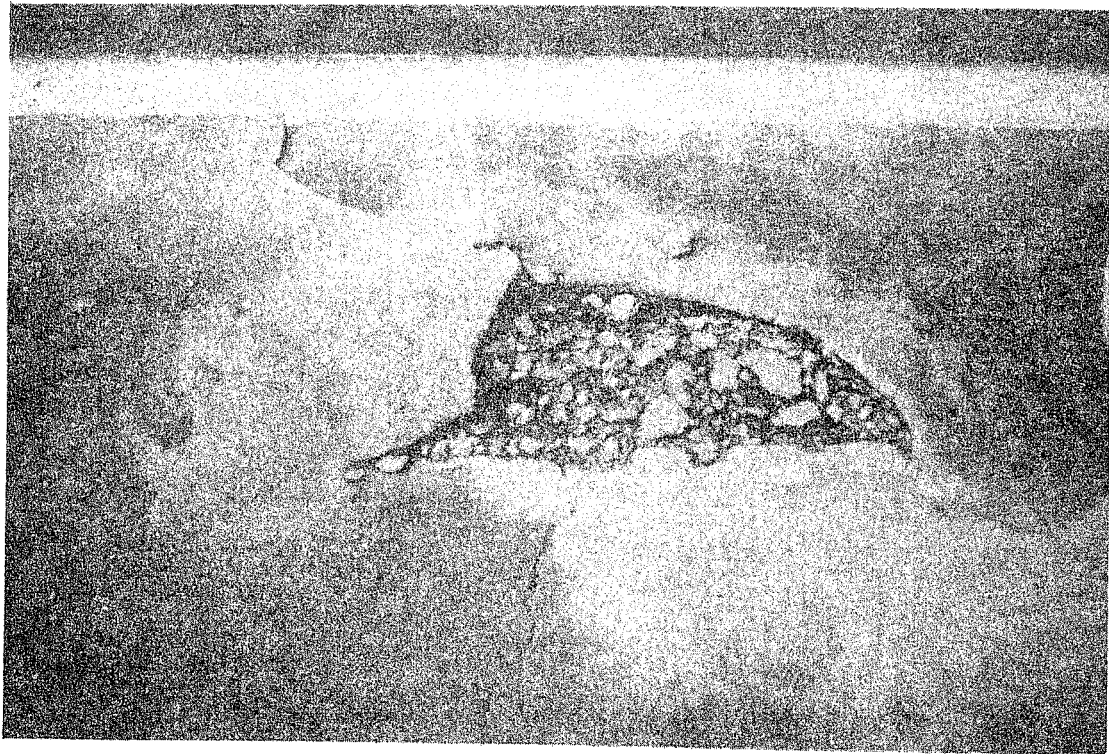
Figure 15. Typical delamination of epoxy overlay, May 1985, Marseilles Lock

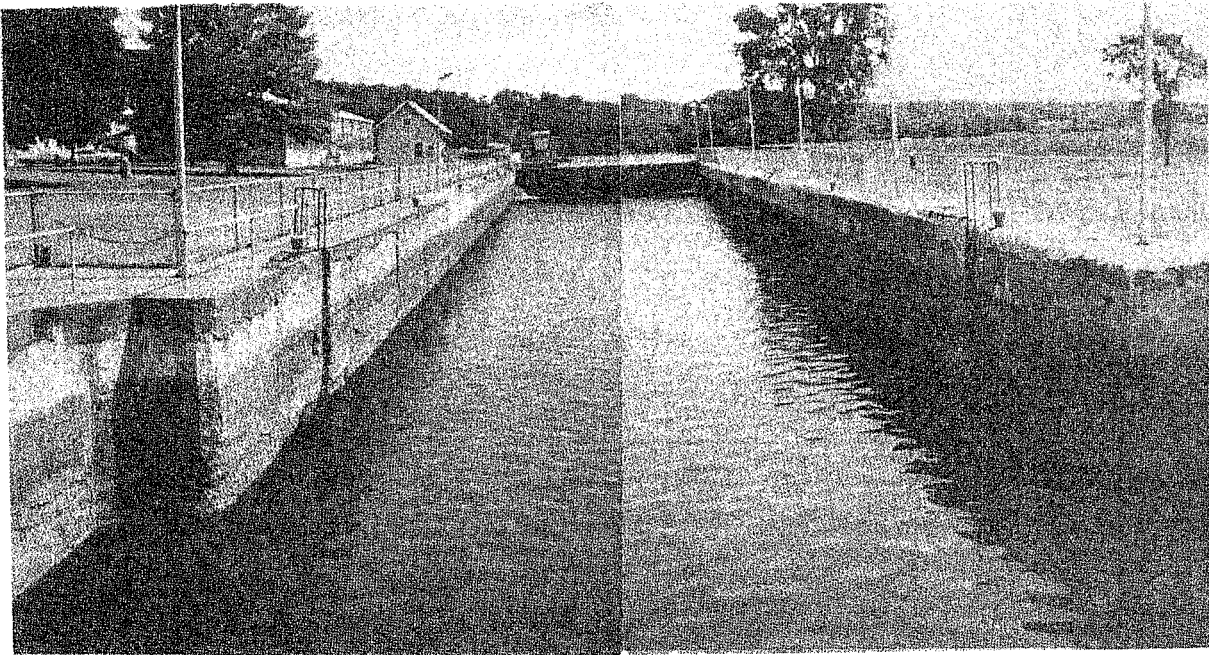
49. After 55 years exposure to the elements, lock concrete surfaces were severely scaled (Figures 17 and 18). An investigation was initiated in 1977 to determine the extent and causes of the concrete deterioration. Two 6-in.-diam holes were core drilled vertically through the landside lock wall and 5 ft into the underlying bedrock. In addition, 6-in.-diam cores were obtained from a total of 12 horizontal and vertical holes drilled to depths of

Figure 17. General view of lock looking upstream 1977,  
Old Lock No. 14, Mississippi River

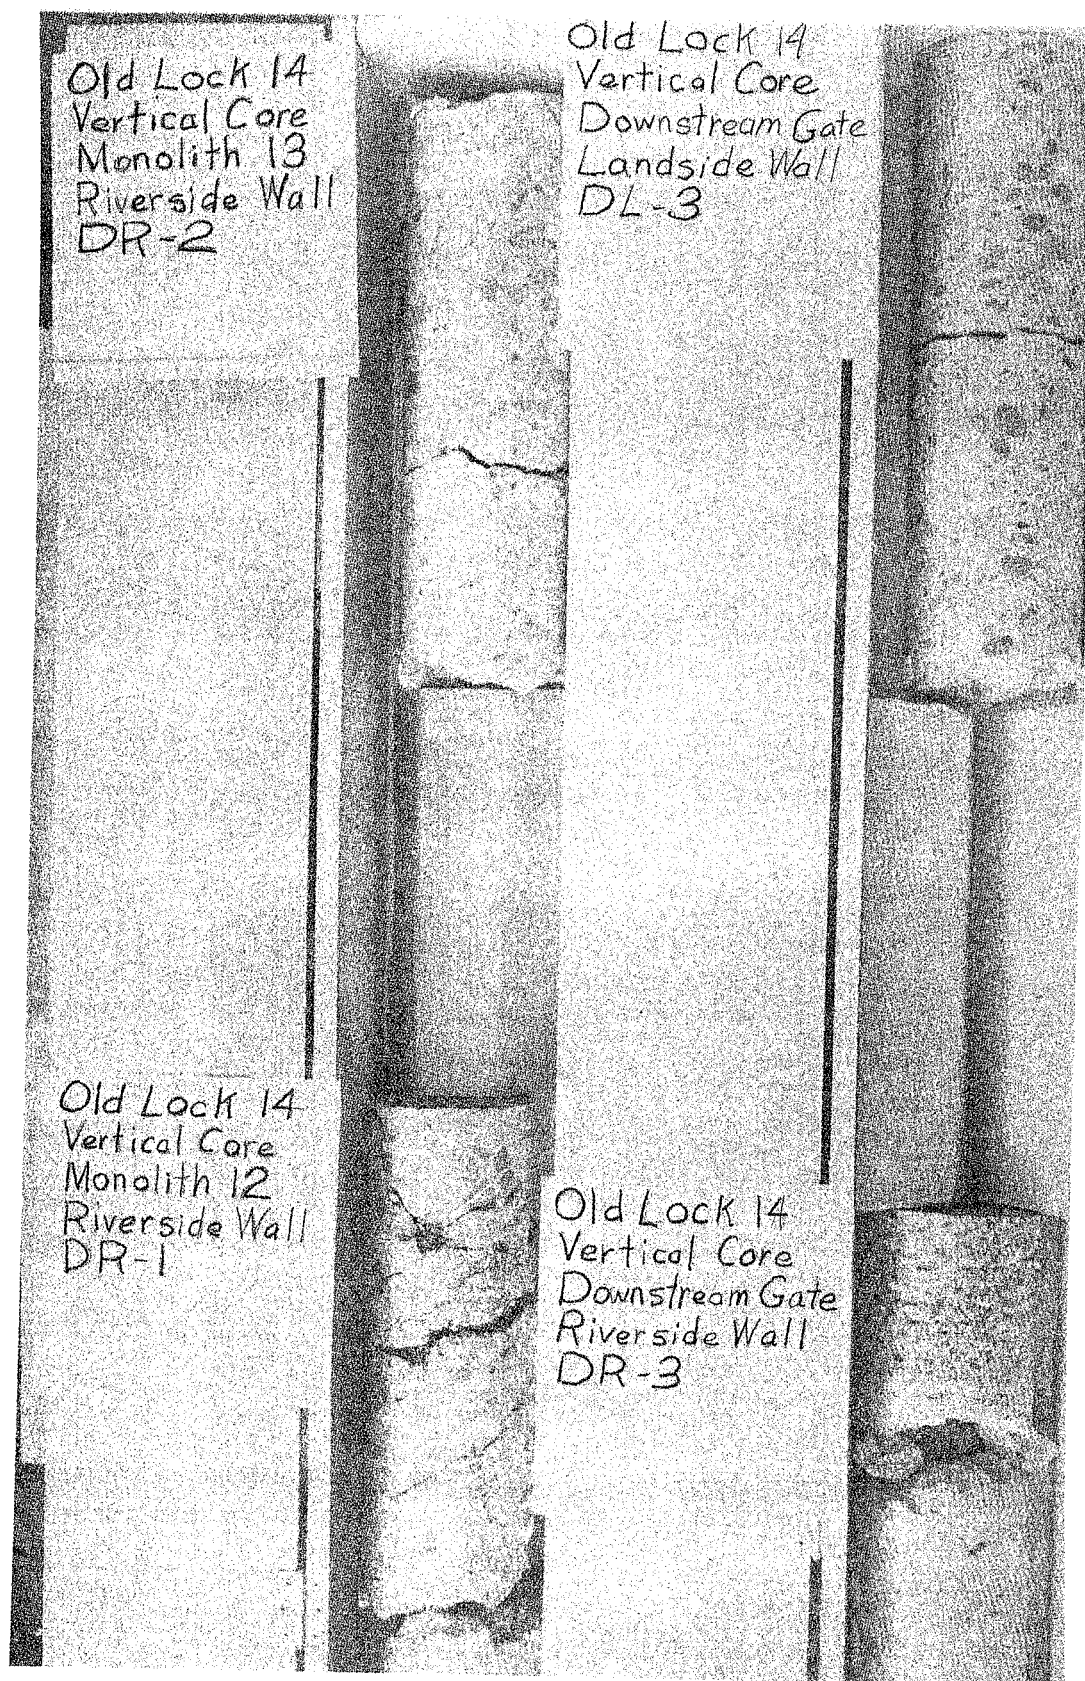
Figure 19. Photographs of selected concrete cores, 1977,  
Old Lock No. 14, Mississippi River

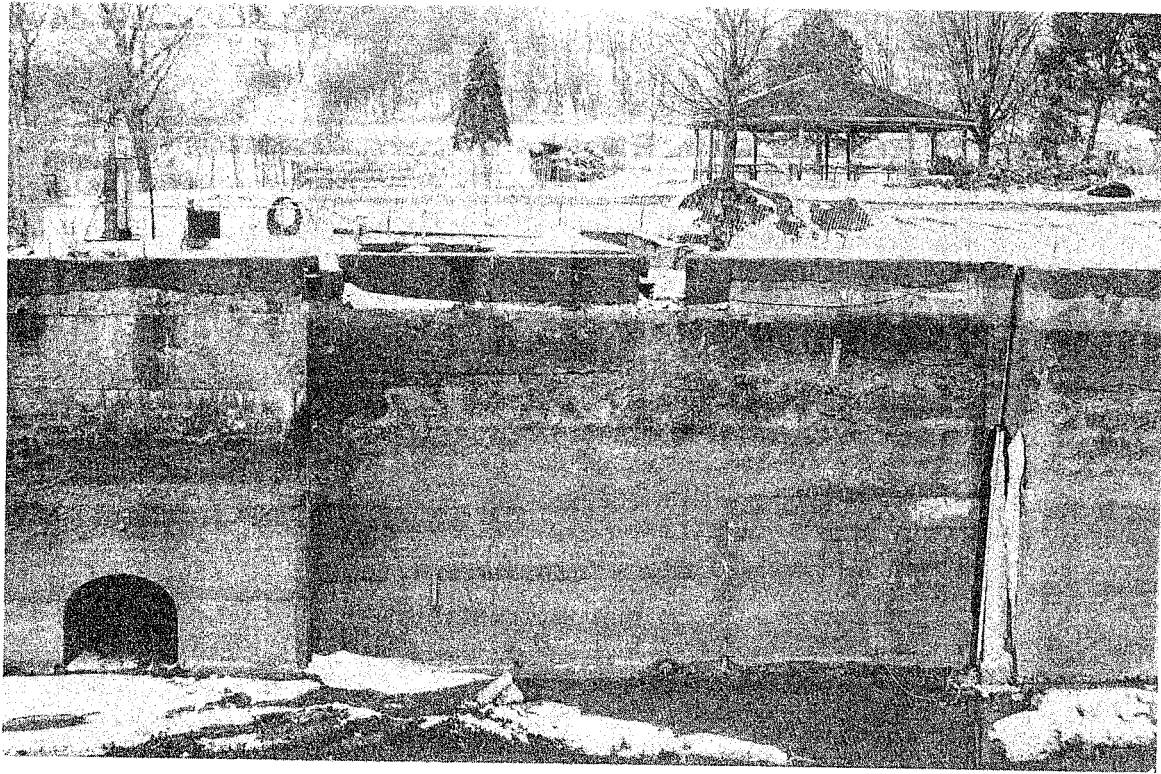
Figure 20. Typical concrete deterioration, February 1980, Old Lock No. 14, Mississippi River

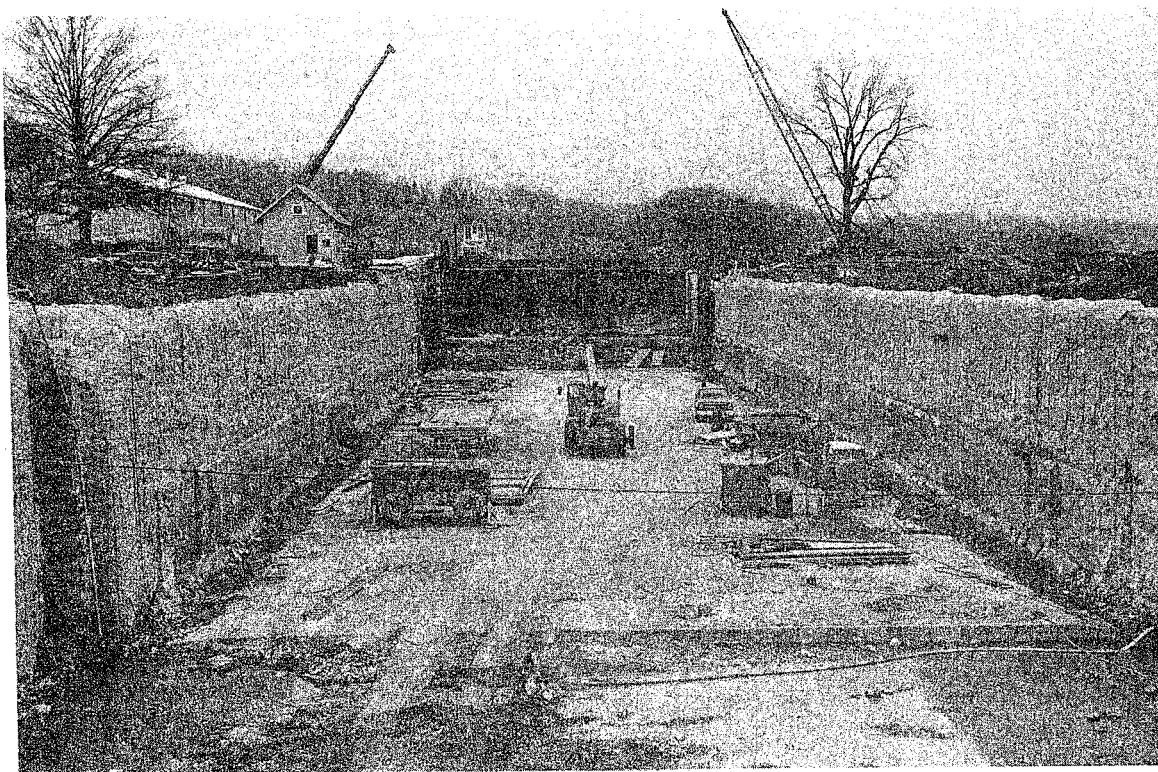
Figure 22. Lock walls following removal of deteriorated concrete, April 1980, Old Lock No. 14, Mississippi River

53. The concrete on the top surface of the walls was removed by drilling 2-1/2-in.-diam holes in a grid pattern and blasting. The holes were loaded with 50-grain detonating cord with one-fifth of a stick of water gel attached at 18-in. intervals and stemmed the full depth. The debris was contained by placing timber mats on the top of the walls and hanging rubber tire mats on the vertical face of the walls. The bid prices for concrete removal was \$140 per cubic yard.

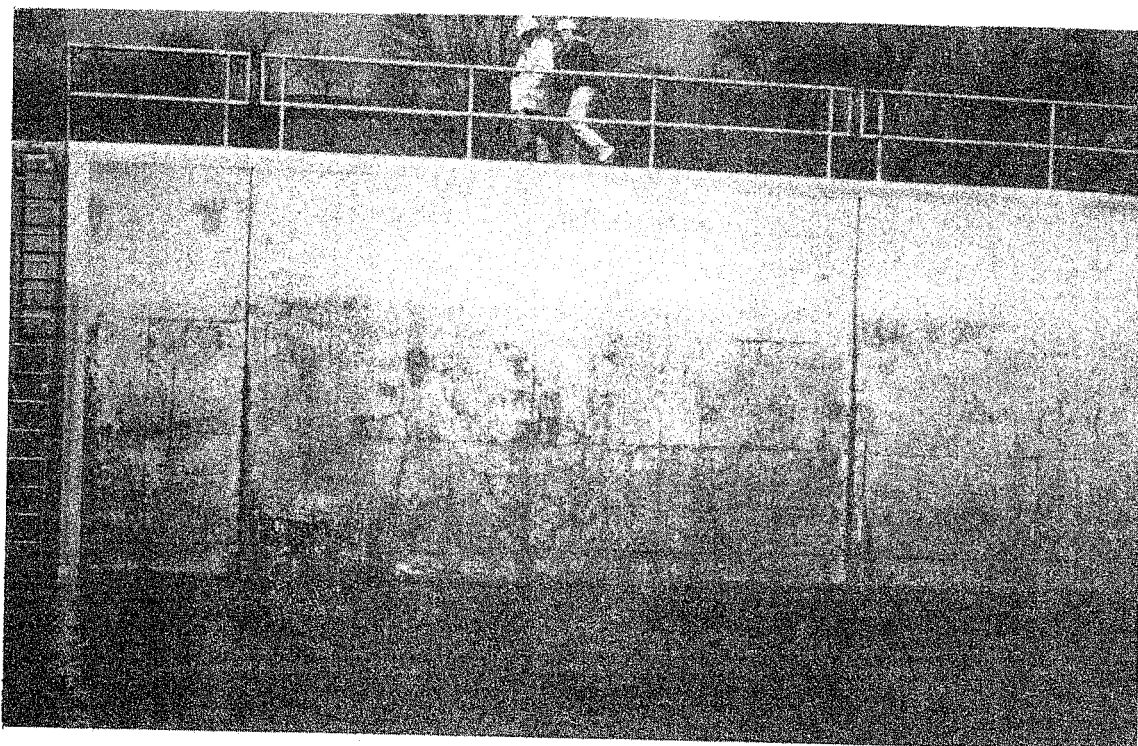
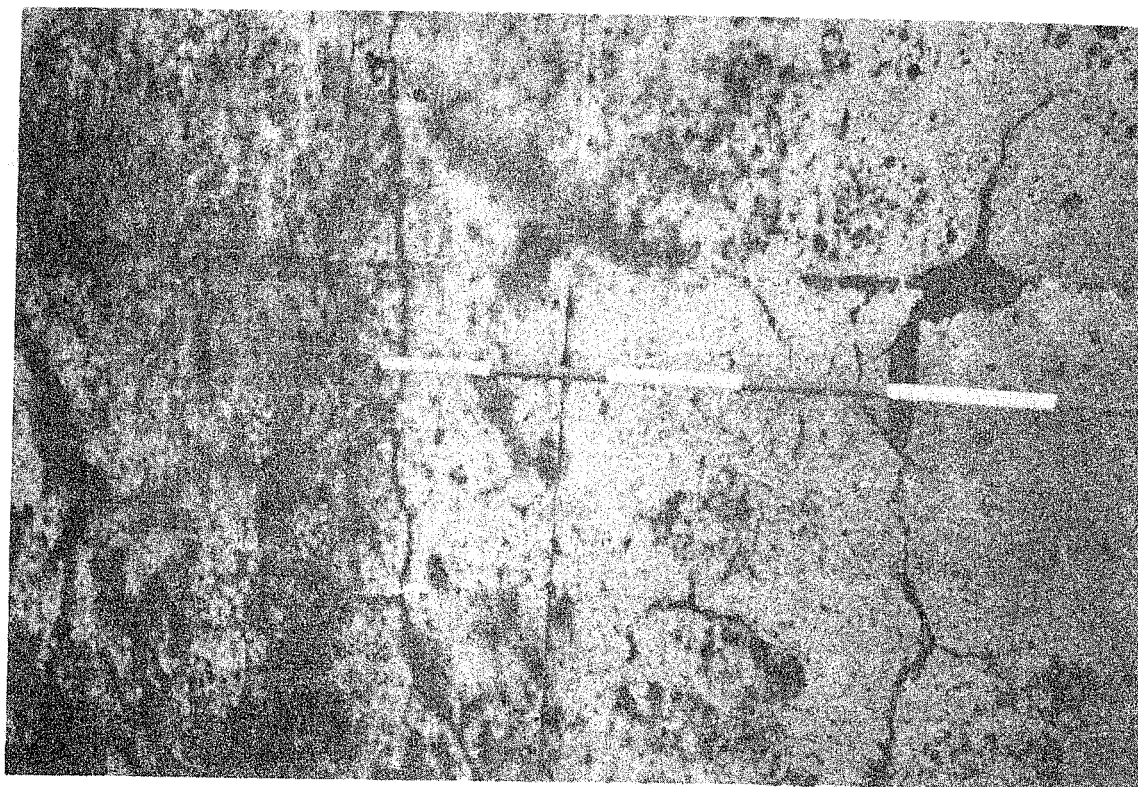
Figure 24. Typical concrete condition, August 1984,  
Old Lock No. 14, Mississippi River

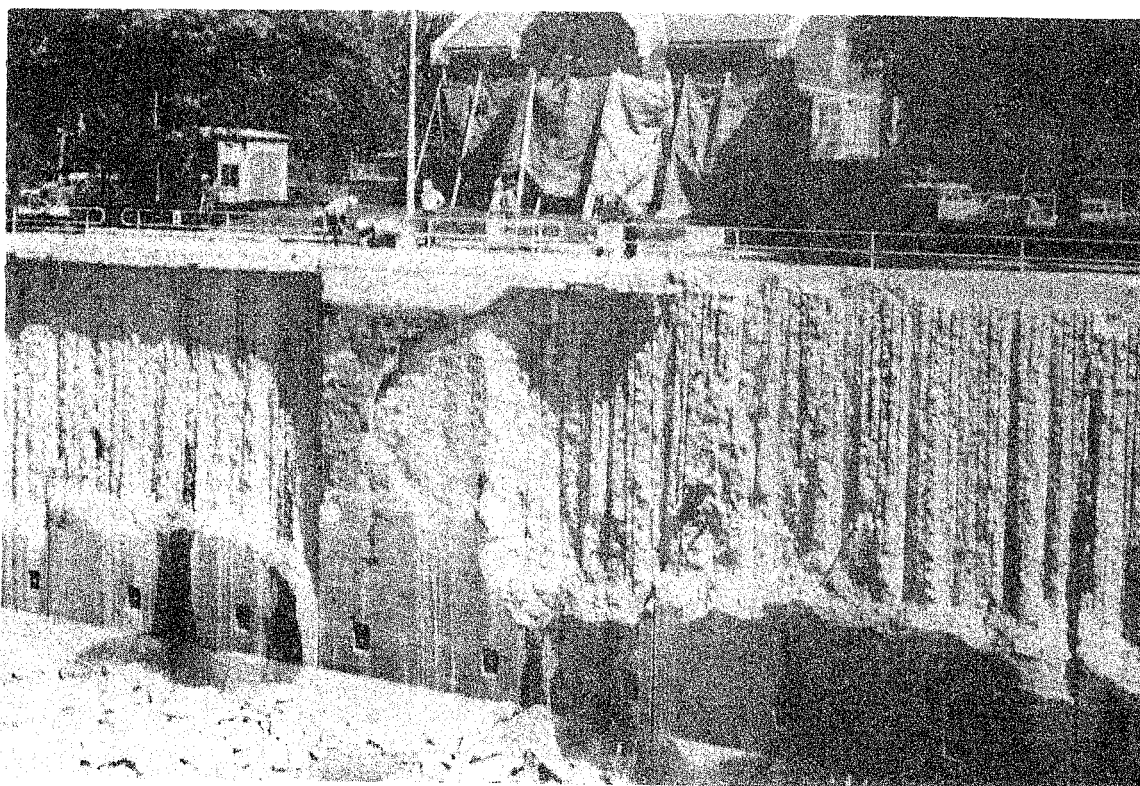
Figure 35. Typical concrete surface conditions after blasting, Dresden Island Lock

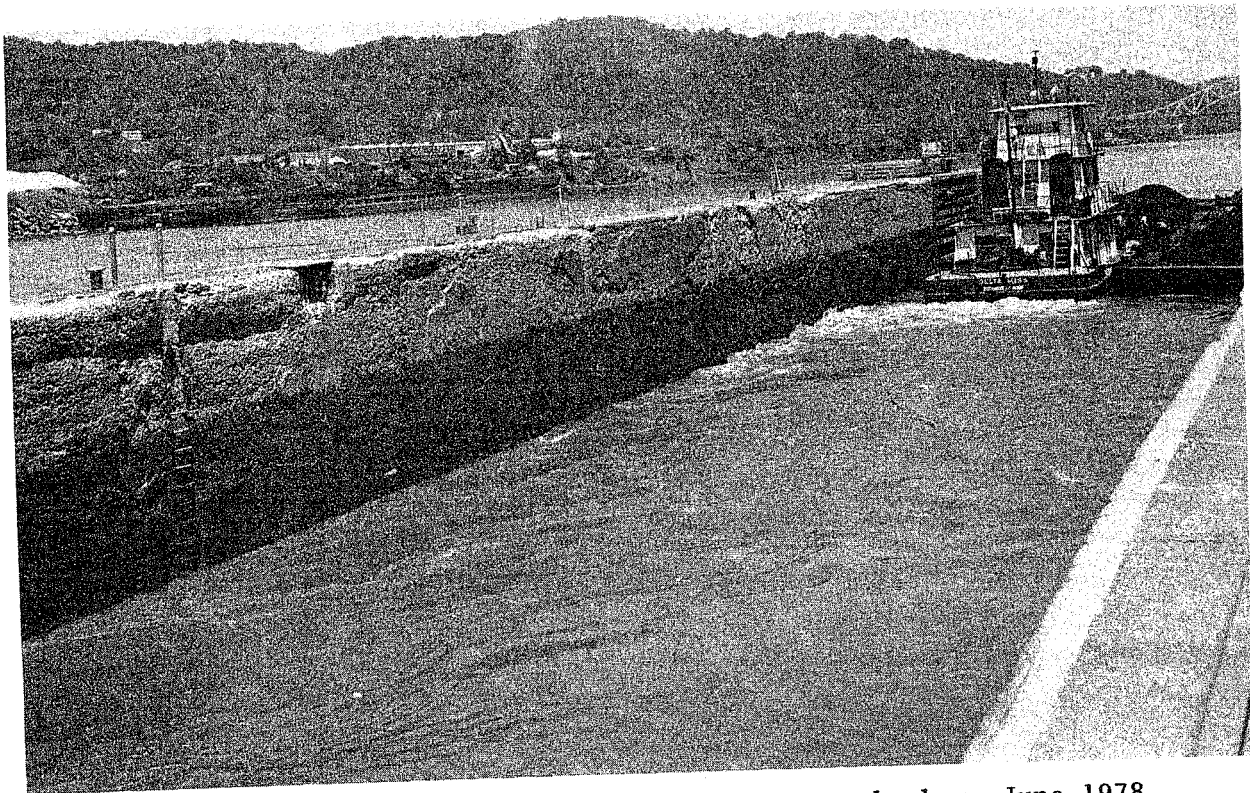
96. From general observations, it was noted that the lock walls were badly spalled and scoured. Previous shotcrete repairs of the wall faces were almost completely deteriorated (Figure 47). The structural beams supporting

Figure 47. Concrete deterioration in river chamber, June 1978,  
Lock No. 3, Monongahela River

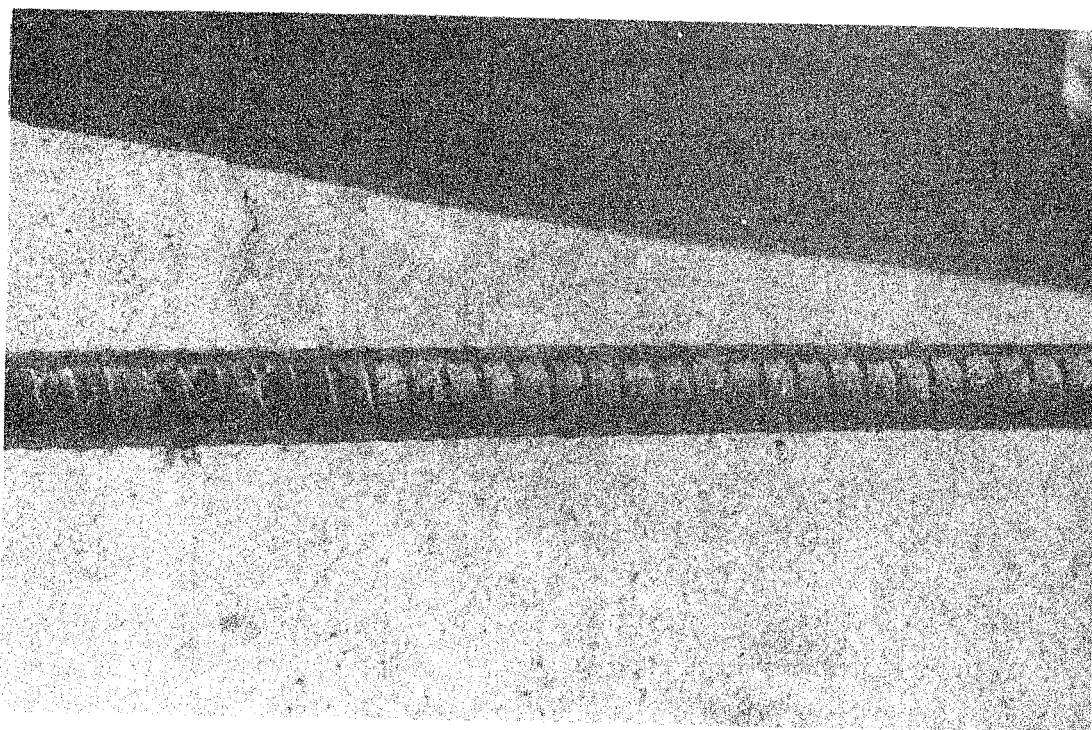
137. A failed anchor was removed from the middle wall and closely examined for any possible explanation of the failure. The general appearance of the bar in the anchorage zone indicated that the polyester resin grout had not bonded to the bar (Figure 57). The lower 5 ft had a light gray material lodged between the deformation of the bar that appeared to be resin grout (Figure 58). However, this resin was soft and pliable and could easily be removed from the bar. In other reaches of the bar, the resin was not soft,

Figure 57. Typical condition of anchorage zone of failed anchor, Lock No. 3, Monongahela River

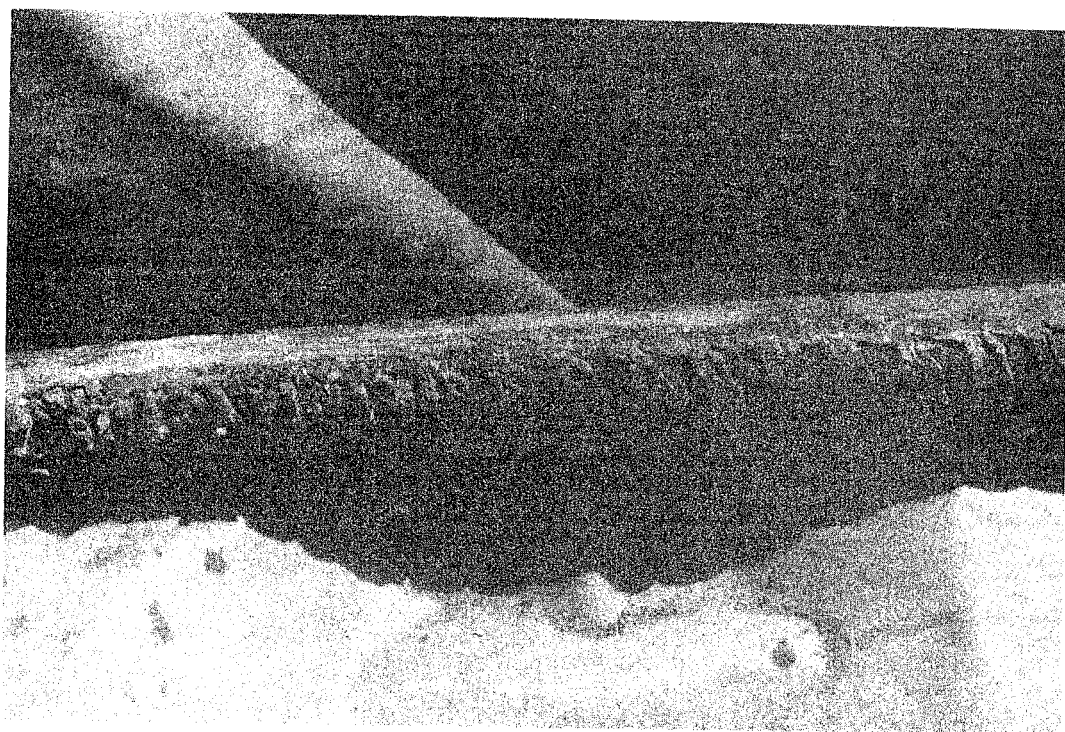
Figure 58. Soft grout lodged between bar deformations, Lock No. 3, Monongahela River

and it was harder to remove from the bar. The contractor claimed that improper mixing occurred because the hole was enlarged by the caving of the hole in the poor rock which would not have happened if he had been allowed to pre-grout each hole. To determine if the 2-1/4-in.-diam hole was possibly being enlarged during drilling, the hole from which the failed anchor was removed was grouted with a reddish grout and a core boring was taken (Figure 59). The core showed that the hole was consistently 2-1/4 in. in diameter.

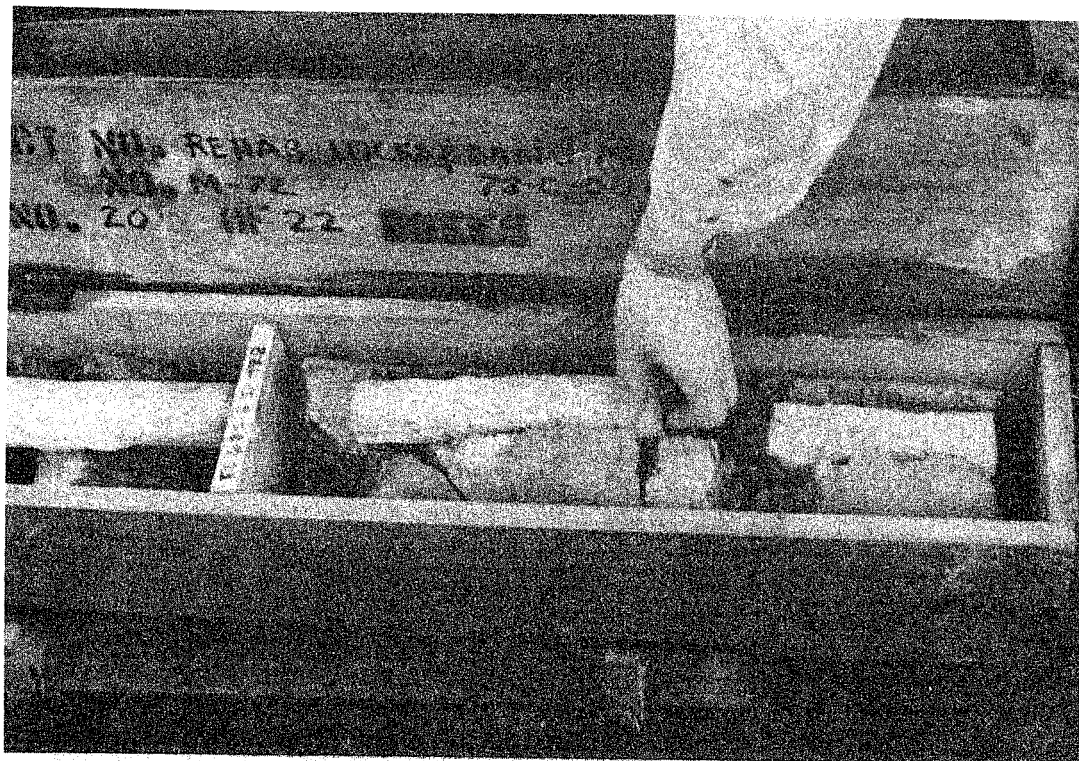
Figure 59. Core from hole where failed anchor was removed, Lock No. 3, Monongahela River

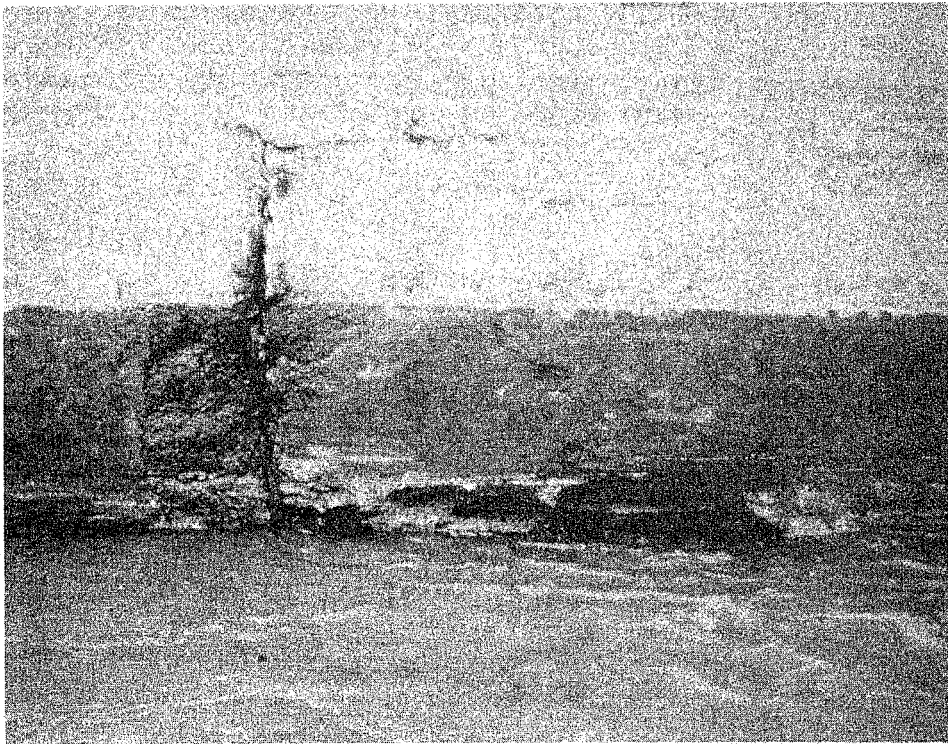
Figure 64. Lock wall concrete deterioration, 1974,  
Lock No. 3, Monongahela River

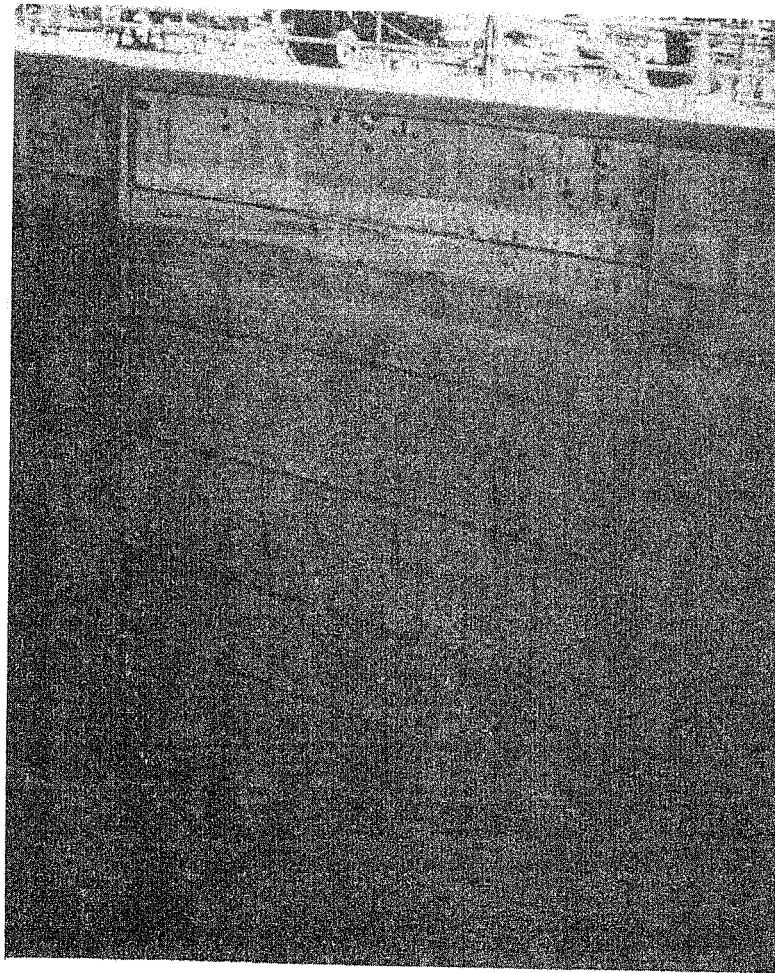
Figure 106. Vertical cracking in the concrete resurfacing, Lock No. 1, Mississippi River

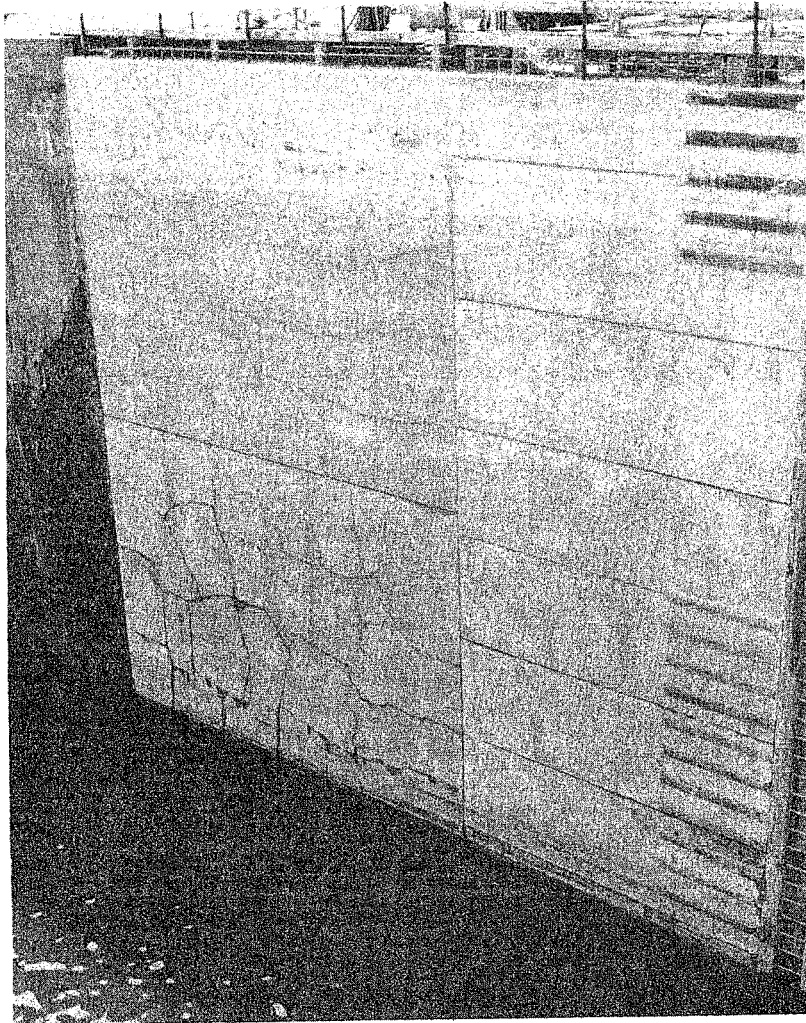
Figure 107. Concrete cracking in a resurfaced monolith (left) compared to reconstructed monolith, Lock No. 1, Mississippi River

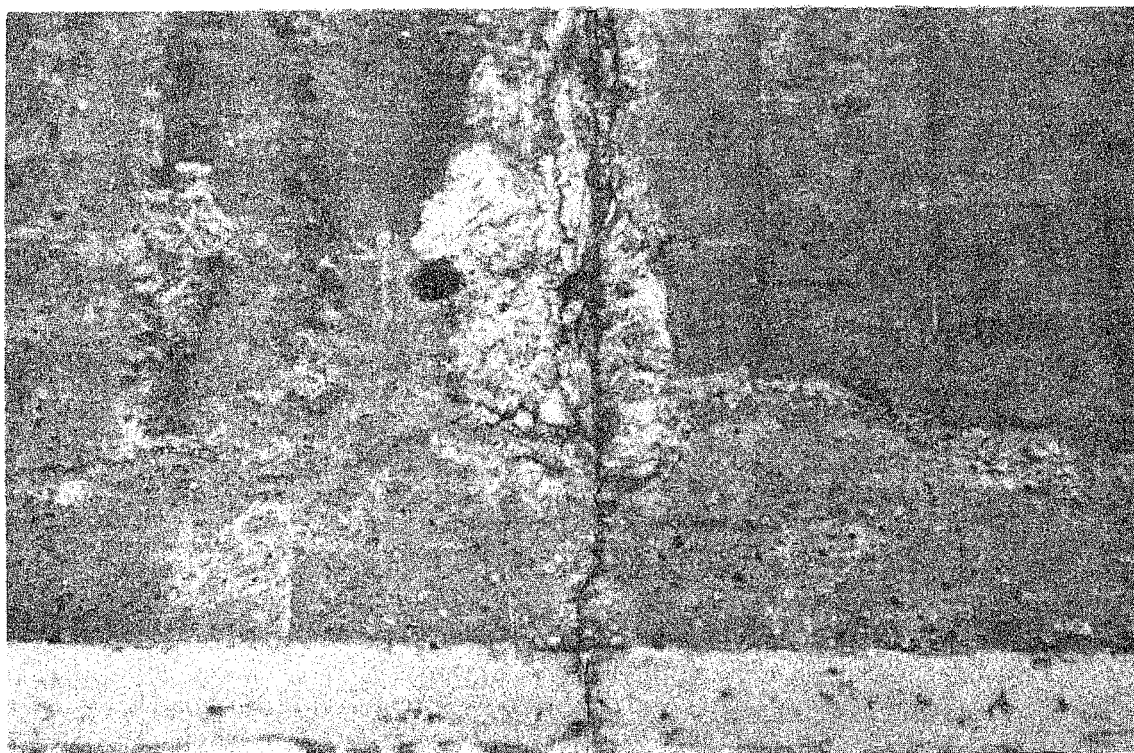
Figure 126. Examples of typical joint deterioration, land lock chamber wall, 1981, Emsworth Locks

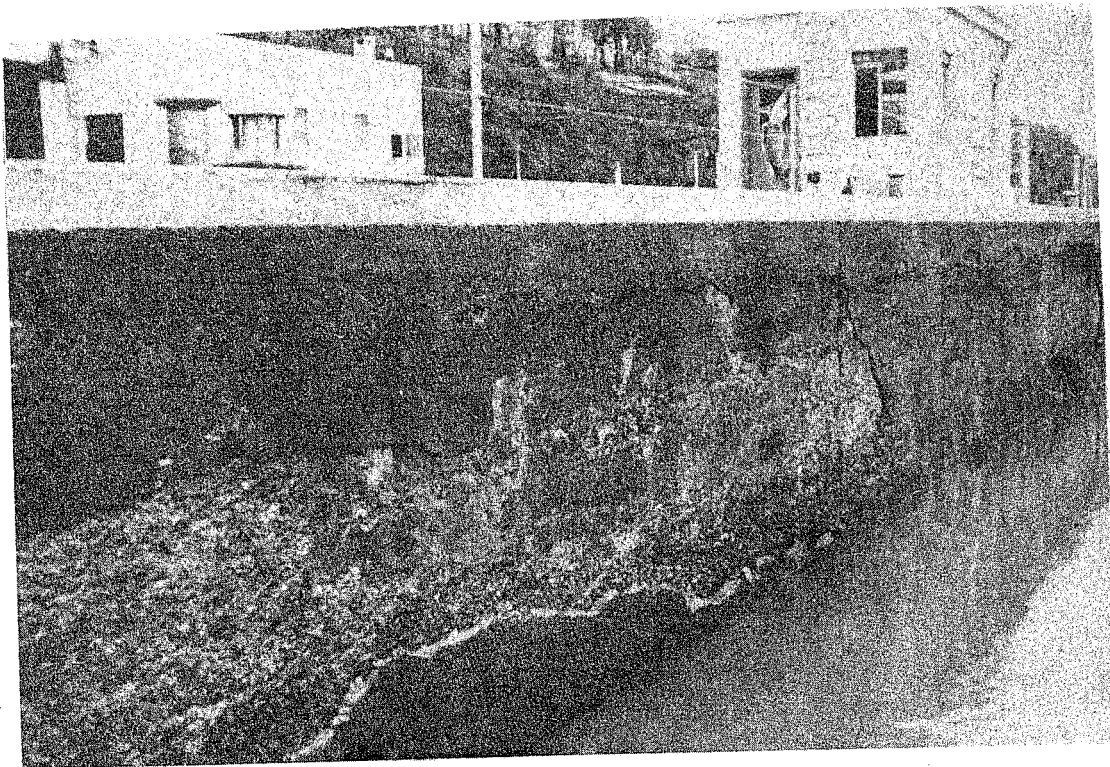
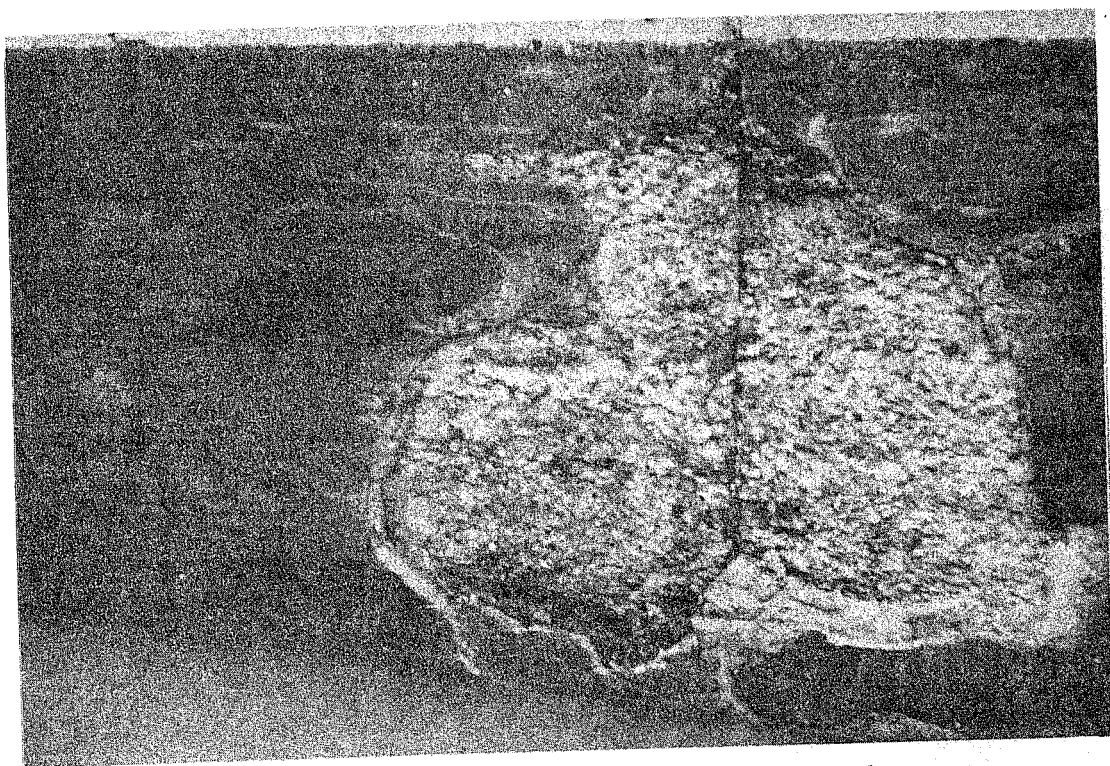
Figure 127. Typical concrete surfaces where shotcrete has spalled on the land wall of the river lock chamber, 1981, Emsworth Locks

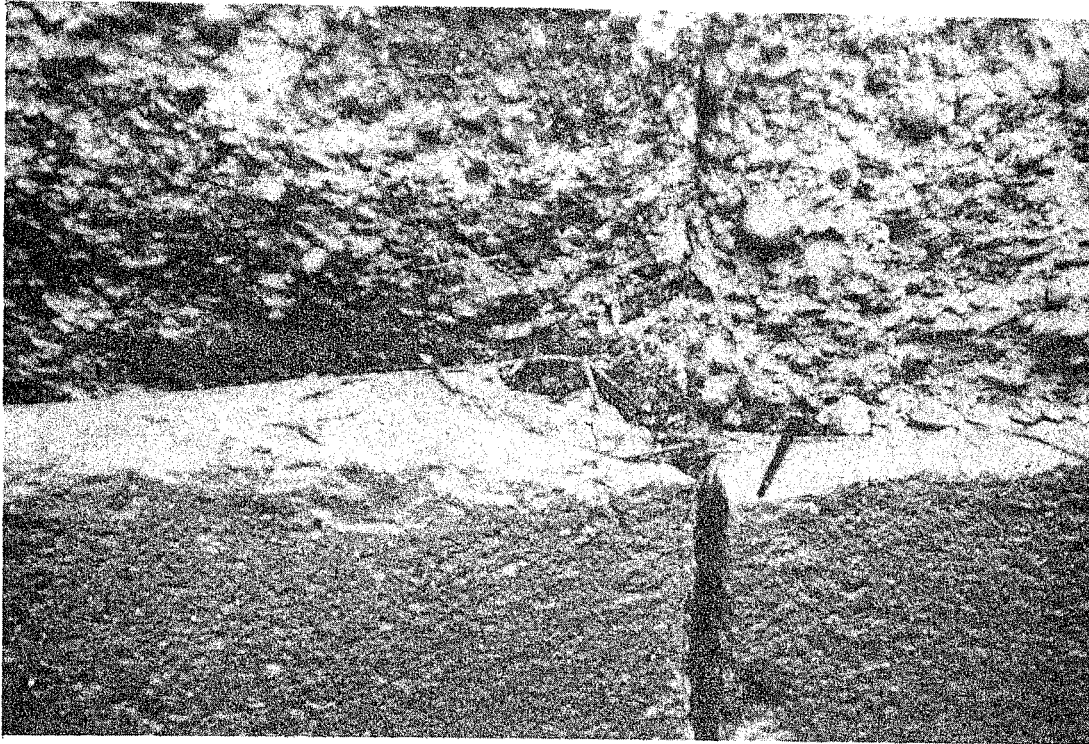
Figure 128. Anchored and reinforced shotcrete remains on the river lock land wall although it was not bonded to the original concrete in several cases, 1981, Emsworth Locks
